Ministry of Transport and Communications

Directorate of Water Resources and Improvement of River Systems

**Case Study
Of
Bo Myat Tun Bridge Waterway Improvement**

14 March , 2017

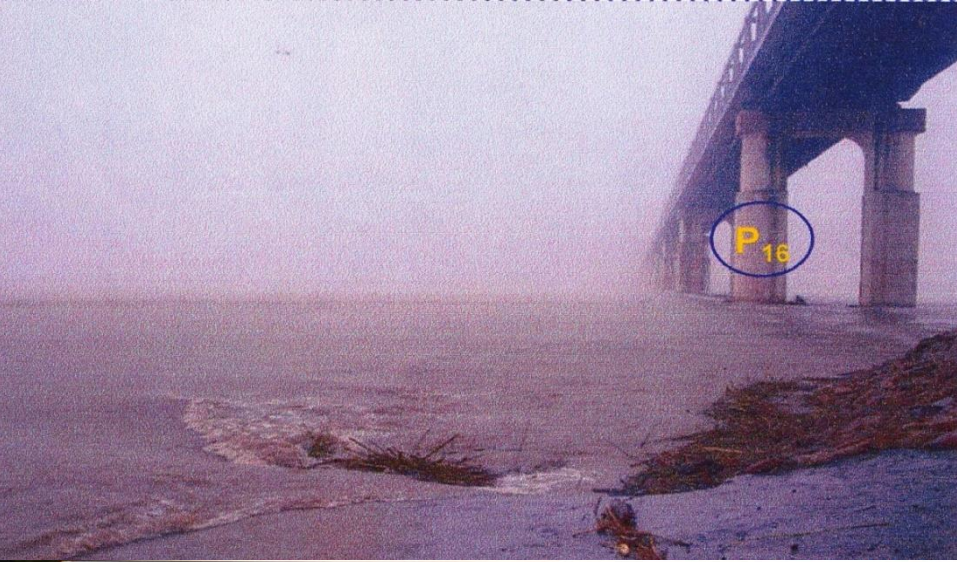
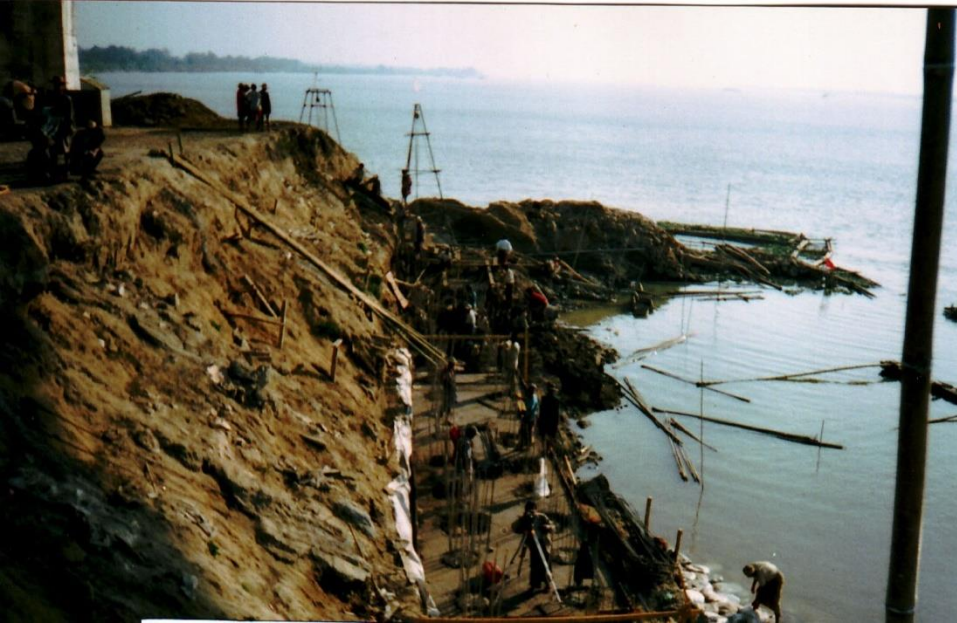
After constructing of Bo Myat Tun Bridge, there are some erosion and land sliding problems along the bank of Kyein Pin Sal Village and near pier no.17.

In consequence, the flow is leading directly to Kyein-Pin-Sal bank which causes deep whirls and reverse whirls

As a result, the flow direction is changed to Kyein-Pin-Sal Bank and water depth became deeper.

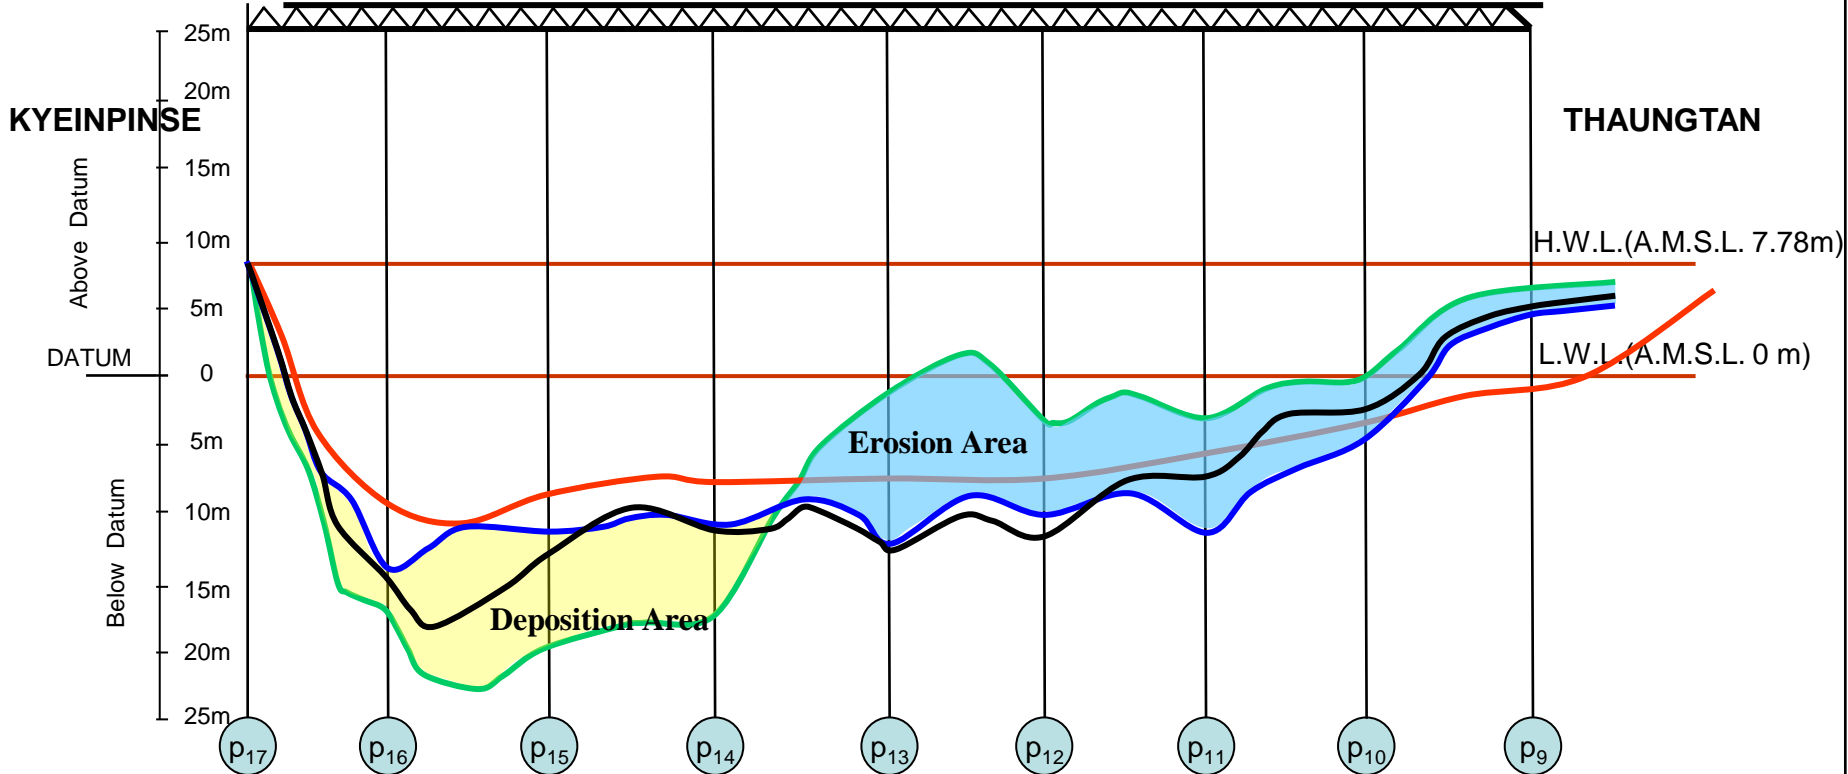
Comparison of River Bed Condition (1997 to 2009)

River Bed Condition at the base of Piers
